**MARYLAND HISTORICAL TRUST
NR-ELIGIBILITY REVIEW FORM**

PROPERTY NAME: Willson's Chance
ADDRESS: 23931 Shore Highway (MD 404), Denton, MD 21629
OWNER: Mary Anne Walsh
TAX PARCEL NUMBER: 105
PROJECT: MD 404 from US 50 to Denton Bypass
SITE VISIT BY: Archaeological and Historical Consultants, Inc.
NAME: Wendy Zug-Gilbert

Willson's Chance

Willson's Chance (CAR-27)

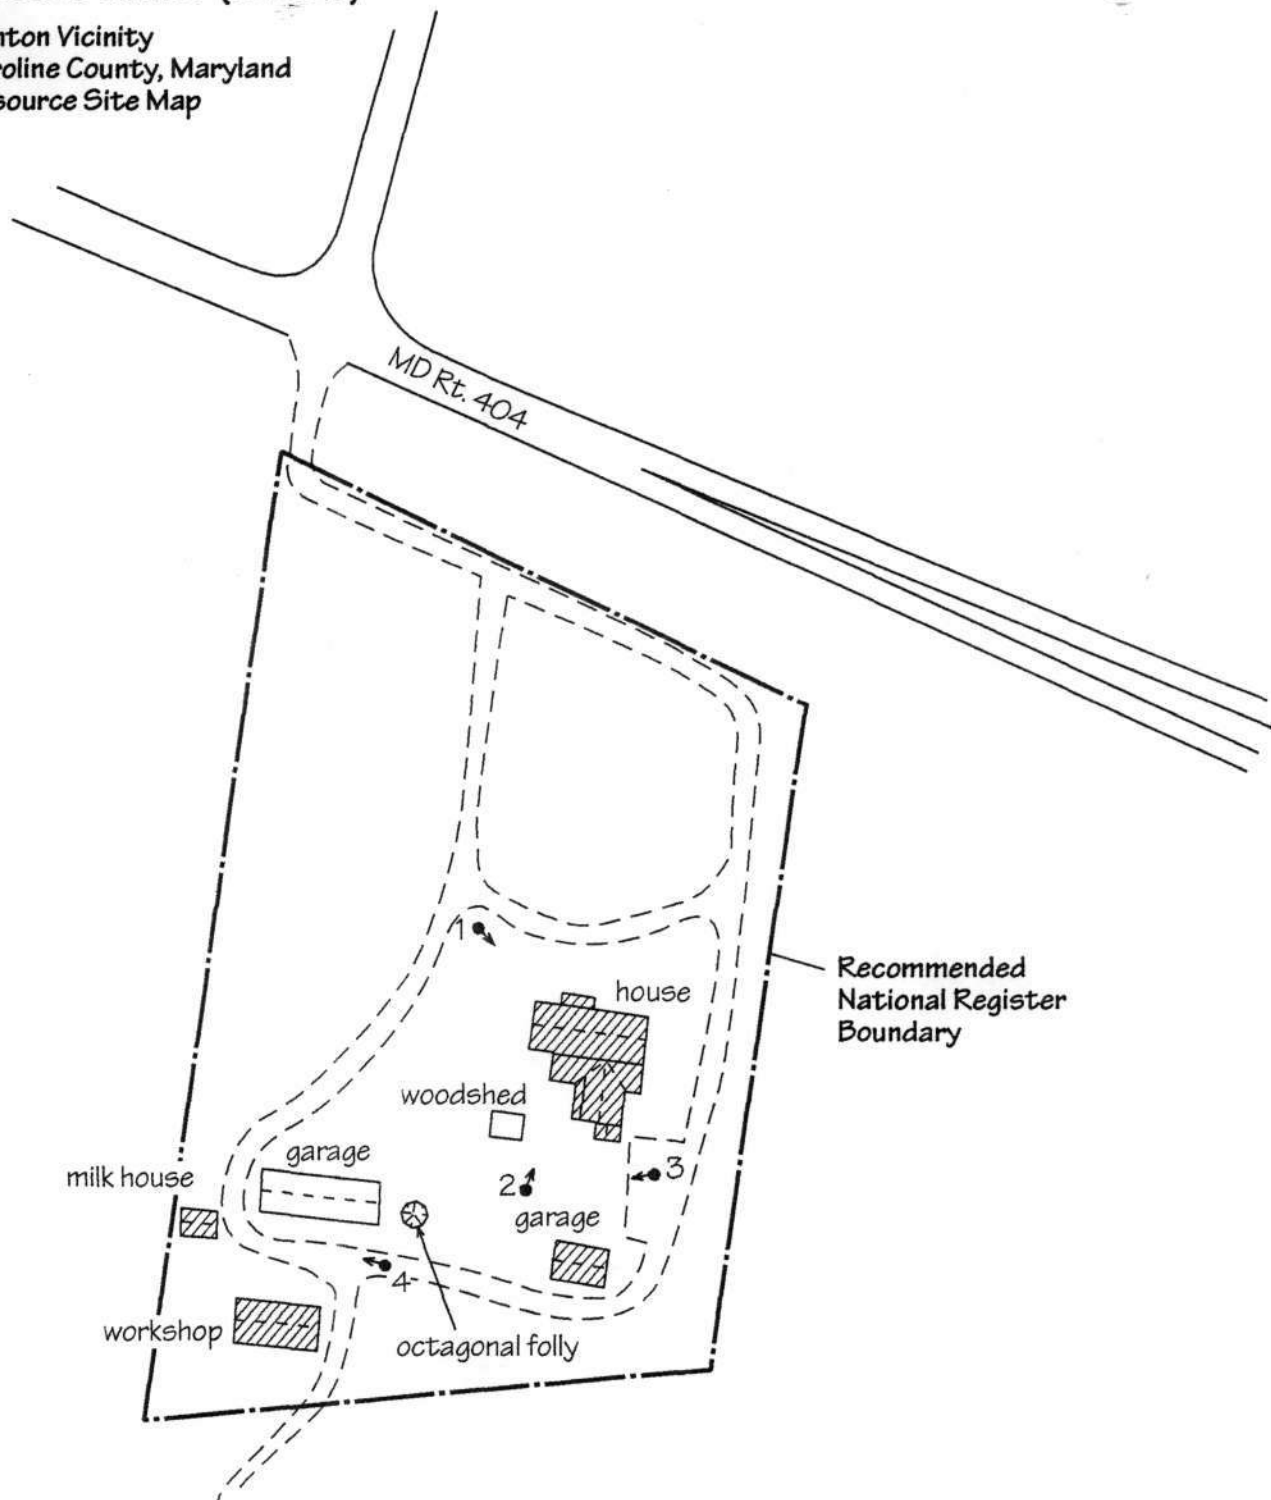
Denton Vicinity
Caroline County, Maryland
Resource Site Map

The recommended National Register boundary for Willson's Chance consists of a 3-acre area (roughly 425' x 300') that is described as follows: Beginning at a point on the southern right-of-way of Shore Highway (MD 404) opposite Holly Road; then south 500 feet to a point; then east 300 feet to a point; then north 350 feet to a point on the southern right-of-way of MD 404; then along the right-of-way 300 feet to the point of beginning. Containing approximately 3 acres. See attached site plan for a representation of this boundary.

Since Willson's Chance is noteworthy primarily for its architecture and not its agricultural history, its boundary was drawn to include the late eighteenth-century residence, its associated outbuildings, the drive up to the residence, and enough acreage to introduce the property and its location on the landscape. Additional farmland was purposely excluded from the boundary since this property is not the agricultural hub of the larger acreage owned and leased out by the current owner.

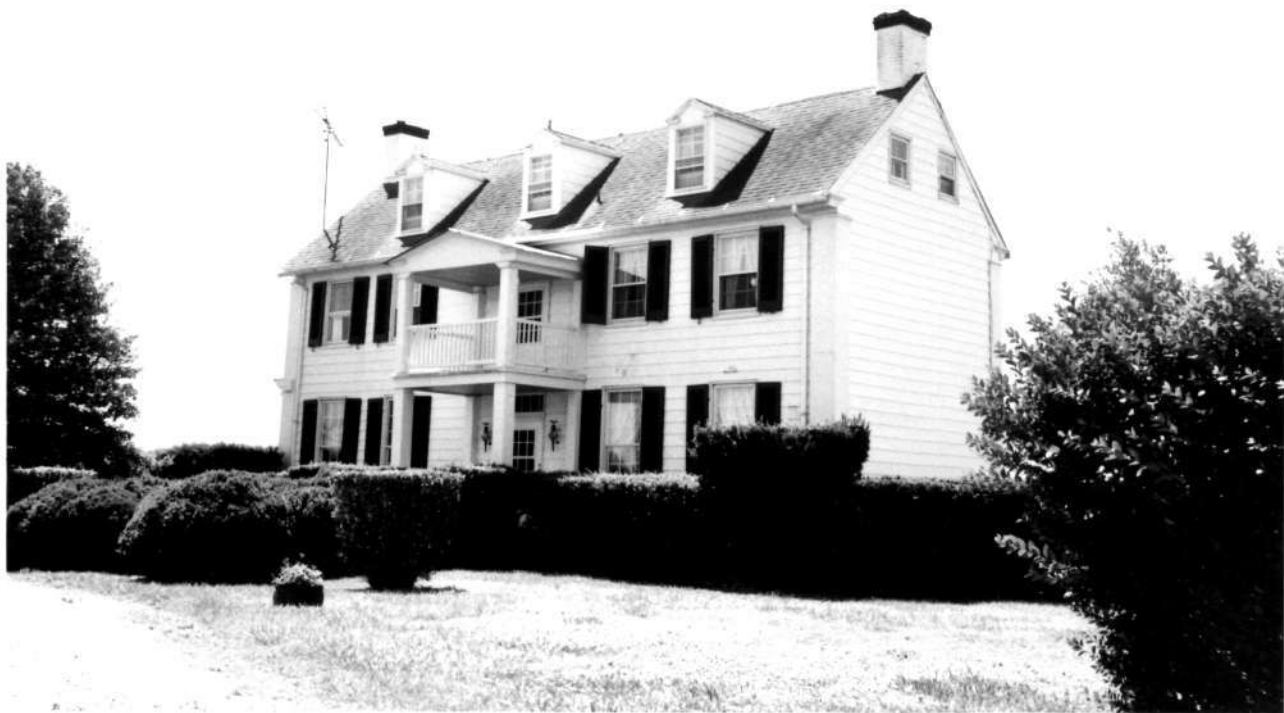
Farmhouse, facade, facing southeast,
1 of 4

The house is a two and one-half story frame structure with a gable roof and interior brick chimneys at both ends. The north facade is five bays with a two story, gable roof central entrance porch supported by columns and with a baluster railing on the second story. 9/6 pane sash windows are on the first story and 6/6 on the second, all with black louvered shutters and 'S' shutter catches. The corners have wood pilaster strips each having two molded panels. There is a box cornice and on the roof are three gabled dormers with 6/6 windows. The west facade has small 2/2 windows in the half story. These are repeated on the east facade, where there is also a Victorian bay window with pierced bracket and dentil cornice. On the east side of the rear facade is a two bay deep ell service wing with two entrance porches.

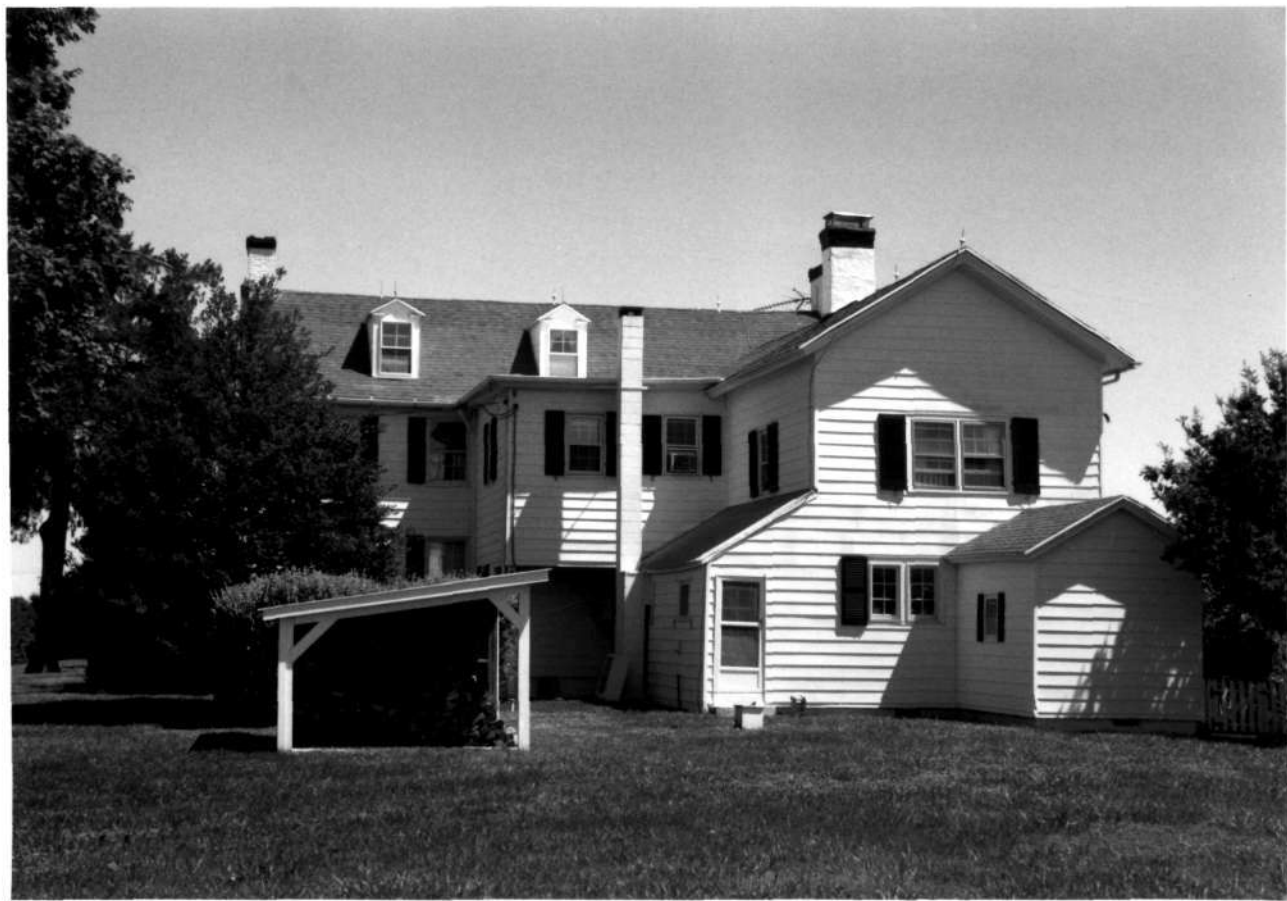
2 of 4

Farmhouse, rear (south) elevation, facing north.

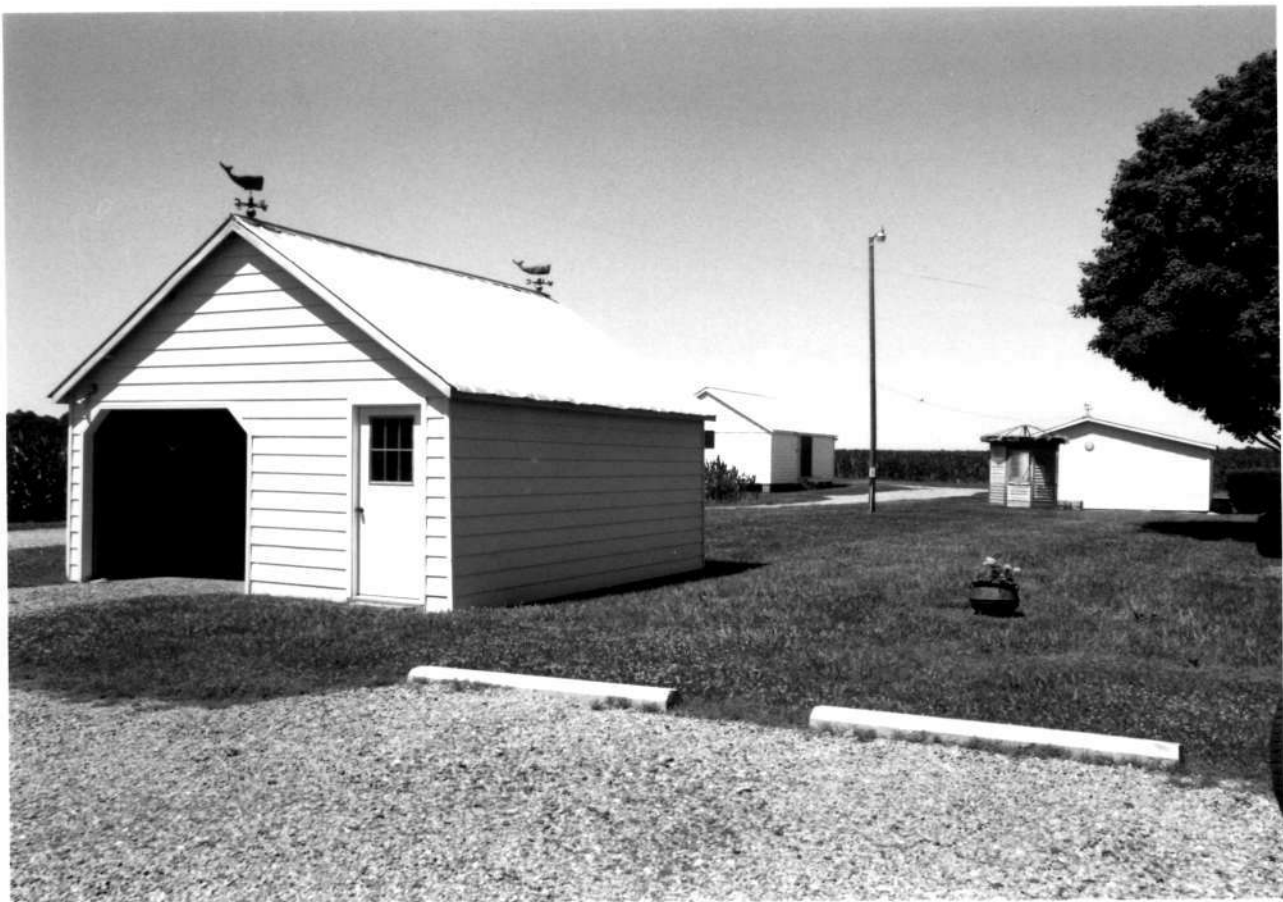
3 of 4

The garage is a single-bay gable-front frame structure on a poured concrete foundation. Its roof is metal and its walls are covered with aluminum siding. The workshop, or original granary, is a large frame structure that sits on concrete block piers, is covered with aluminum siding, and has a side-gabled metal roof. The milkhouse is a small gabled structure built of rusticated concrete block with a metal roof. The "folly" is an octagonal frame structure with windows. The roof is in need of repair.

Out buildings (garage, workshop, folly, garage), facing west

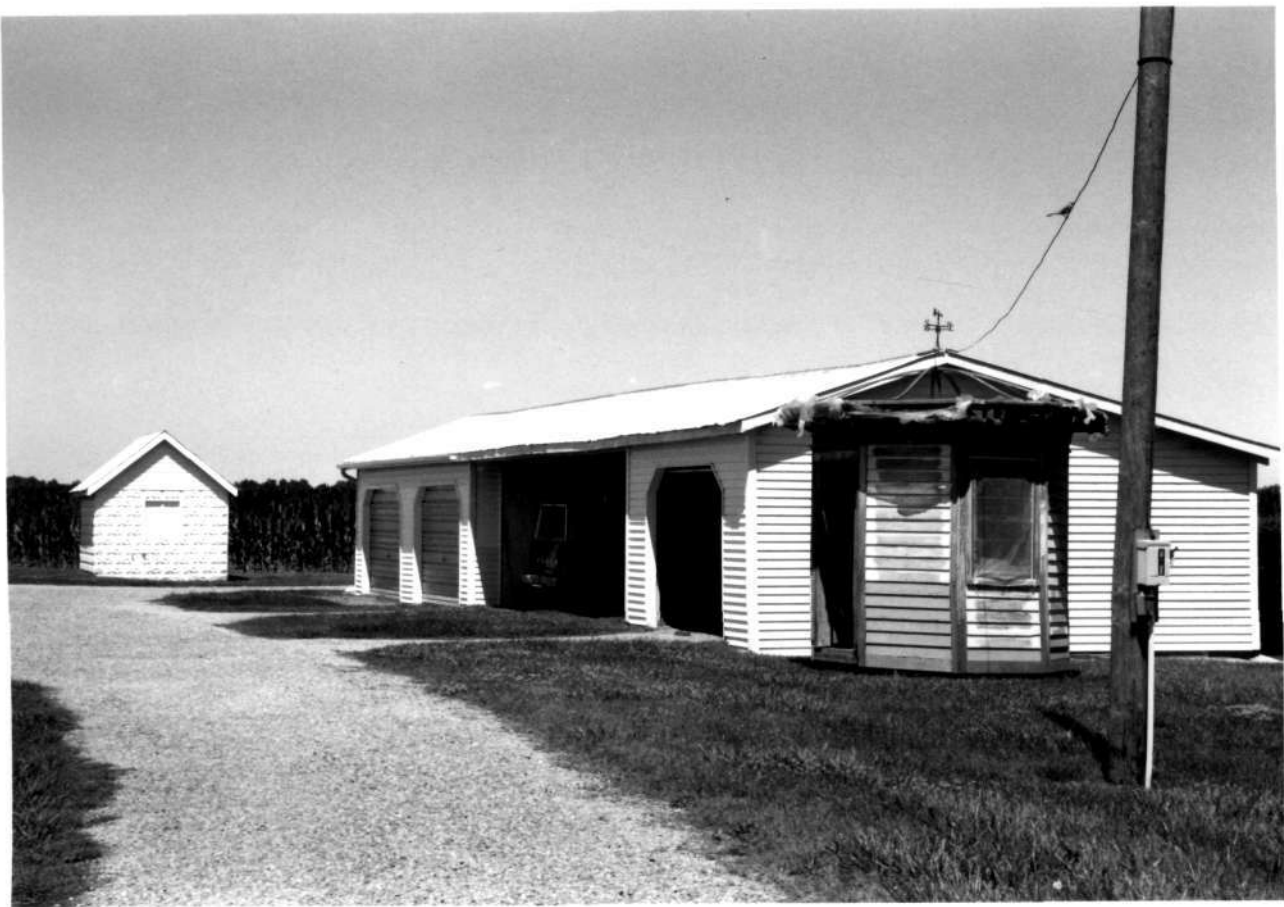
4 of 4

Outbuildings (milkhouse, garage, folly), facing west.
